**WOODBIDGE RESEARCH FACILITY
1995 ASBESTOS SURVEY**

WOODBIDGE, VIRGINIA

FINAL REPORT

October 6, 1995

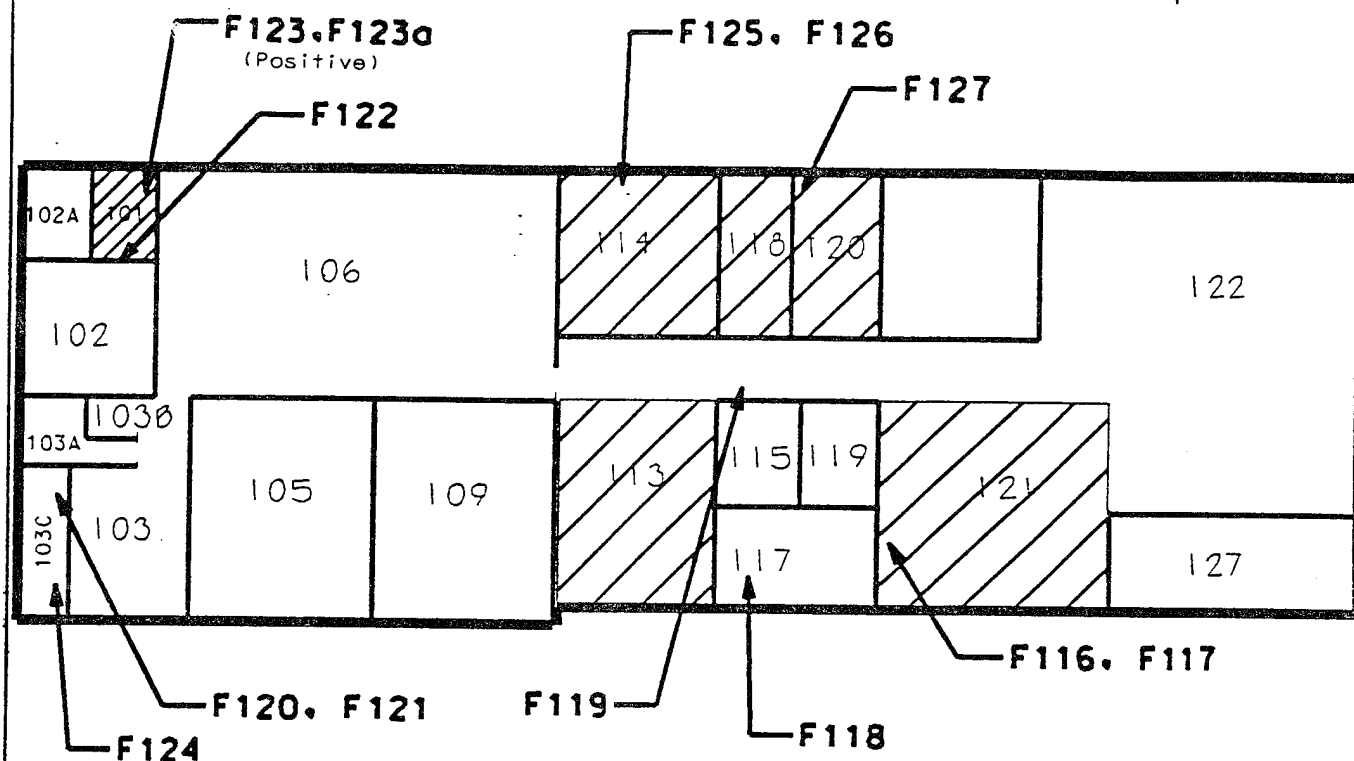
Building # 202

- One of the eleven samples collected from building 202 contains asbestos. The 12"x12" green and gray floor tile with white streaks in room 101 contains 5 to 10 percent chrysotile asbestos. The mastic from this tile is also an ACM containing 1 to 5 percent asbestos.

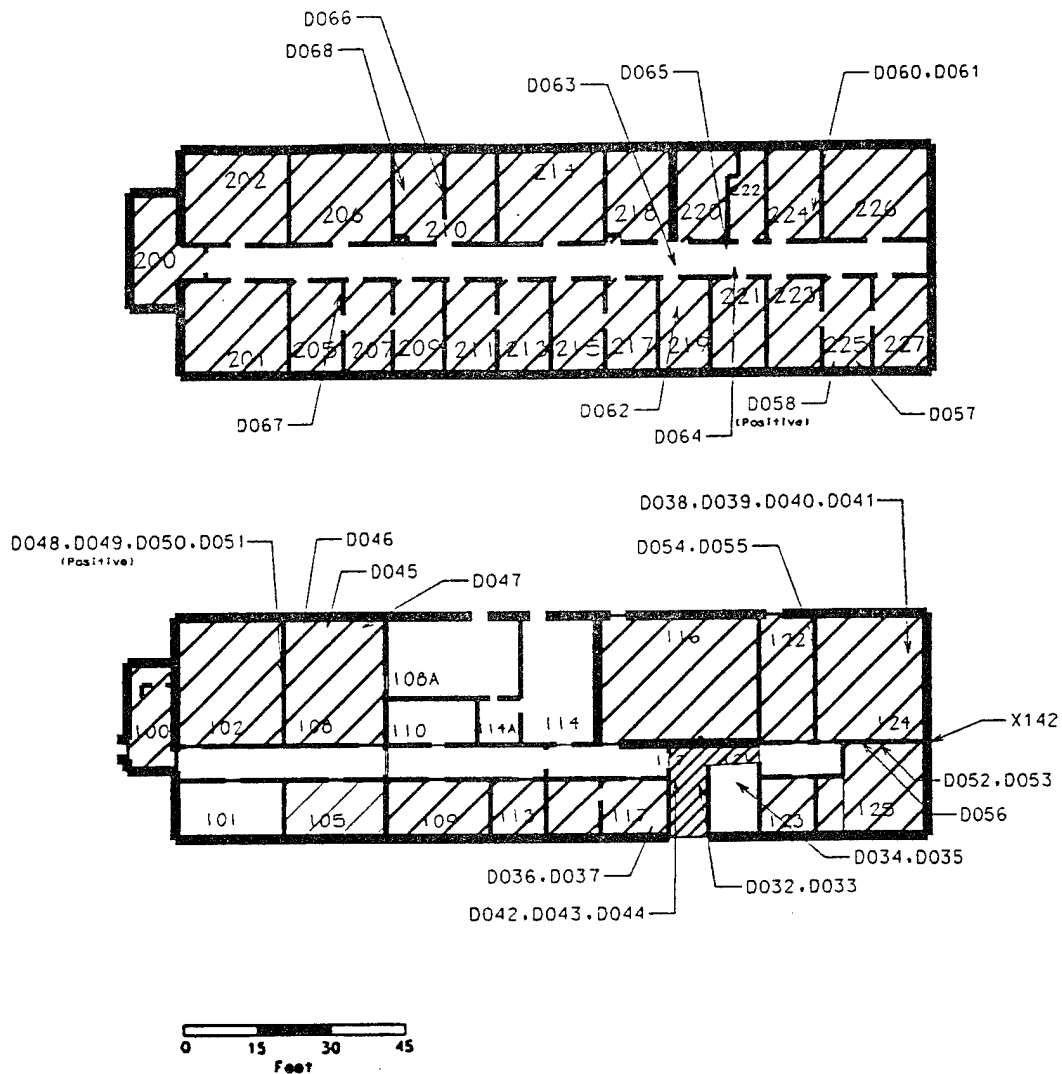
Building # 203

- Two of the thirty-eight samples collected from building 203 are ACM. White glue on the duct work in room 102, and the black glue on the duct work in room 225, contain 5 to 10 percent chrysotile asbestos.

The 9"x9" floor tile assumed to be an ACM is present in buildings 101, 201, 202, and 203 at the locations noted on the drawings in Appendix A. This floor tile is in good condition except a water damaged area in room 108 of building 203. The water damaged area is ten feet in diameter with loose warped tiles exposing another layer of 9"x 9" tiles underneath them. The asbestos in the tile is not friable and does not pose a threat to human health. According to State and Federal Regulations, the tile does not have to be removed. According to the 31 October 1994 memorandum from the Office of the Under Secretary of Defense, Subject: Asbestos, Lead Paint and Radon Policies at BRAC Properties, the ACM is not to be removed. ACM is only removed when it is "of a type and condition that is not in compliance with applicable laws, regulation, and standards, or if it poses a threat to human health at the time of transfer of the property." Horne Engineering completed a USAEC Asbestos checklist for the 9"x9" tile overall and for the water damaged area, both have an assessment index of "E - Monitoring."

Continue Special O&M program. Take steps to prevent damage to the ACM. Monitor the condition of all ACM frequently.

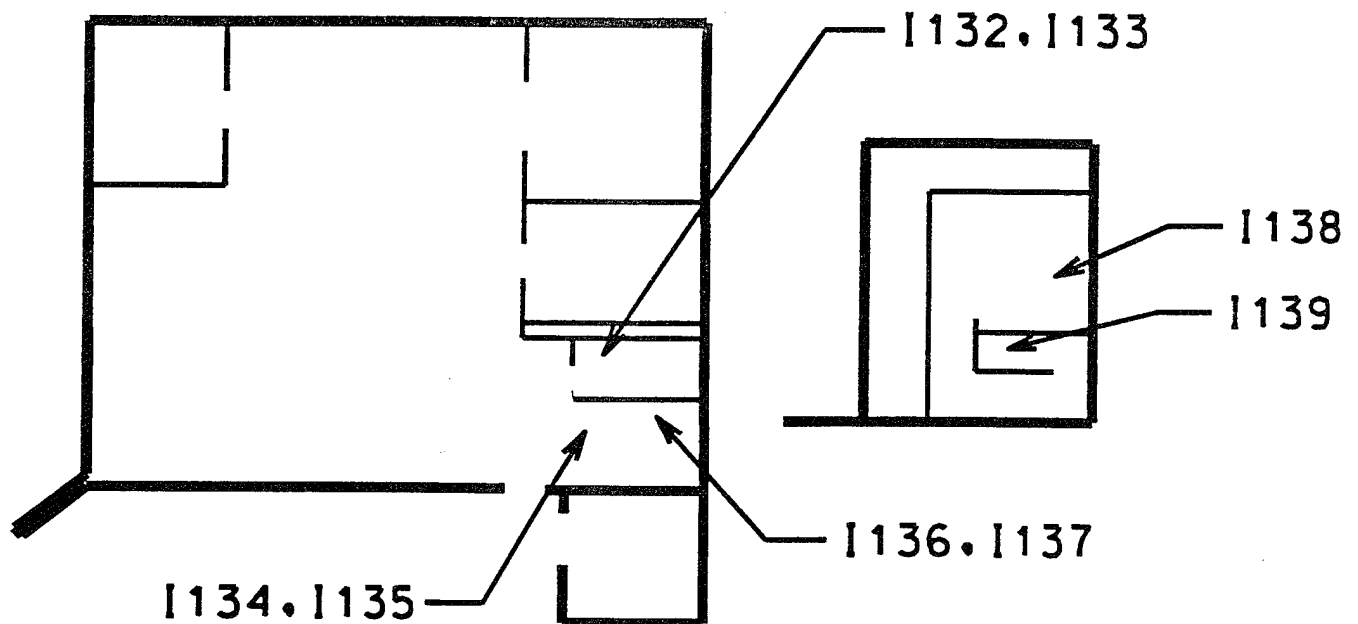
Building # 211

- One of the nineteen samples collected from building 211 is an ACM. The white duct glue on the duct work above the suspended ceiling in room 307 contains 10 to 20 percent chrysotile asbestos.
